HISTORIC STRUCTURE REPORT

Thomas H. Moore House
2201 Dixie Avenue SE, Cobb County
Smyrna, Georgia 30080-1578

Prepared for: Joel Powell, Property Owner
Prepared by: Conservation of Historic Building Materials Class
Georgia State University, Fall 2013

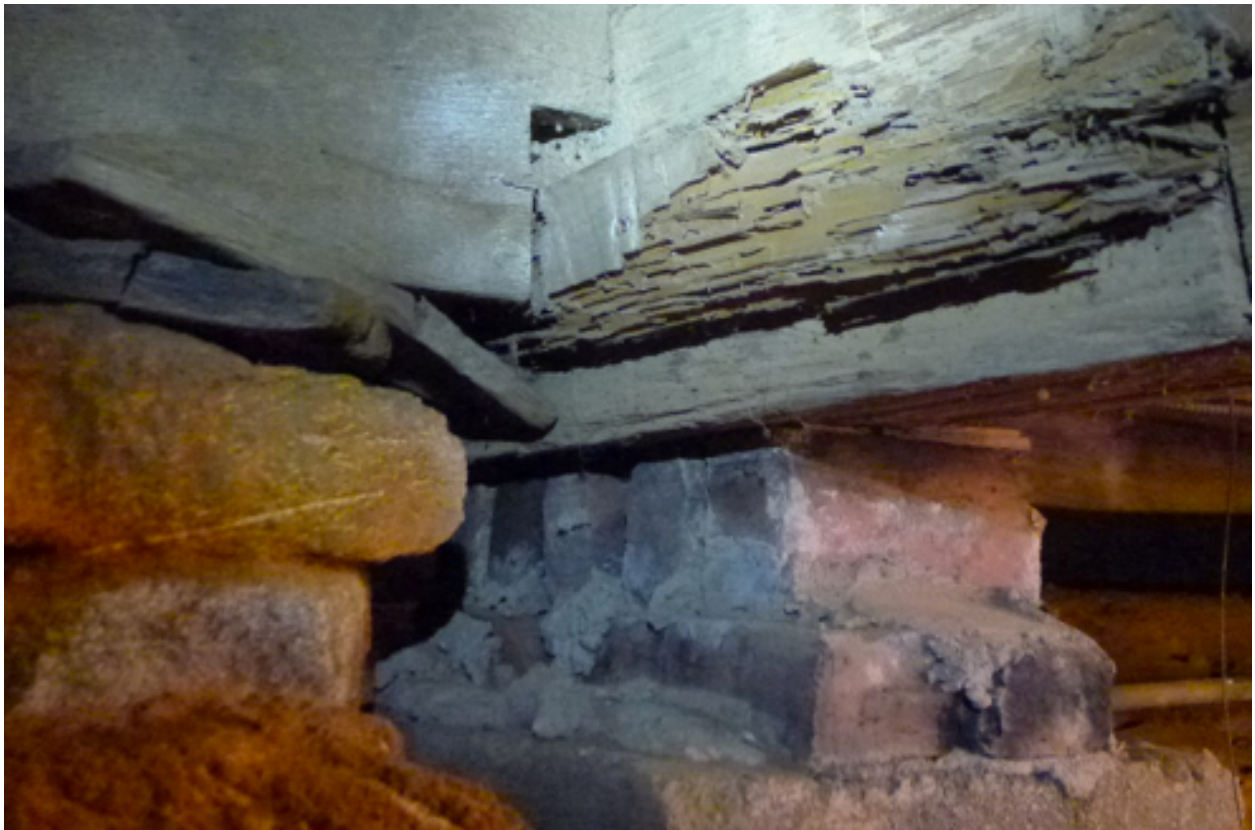
Two new cinder-block piers were installed on either side of the staircase to continue supporting an original timber spanning across the space that was cut through in order to construct the staircase (Figure 3.45). Other timbers were cut to allow space for HVAC systems and duct work. A number of make shift support systems were constructed to make up for shifting load bearing supports when the space was dug out. These include plywood shims into uneven crevasses, and the use of stones to balance shifting and crumbling piers affected by the changes to the foundation (Figure 3.46).

Figure 3.46: Concrete piers replace brick piers to hold up circular-sawn sill.

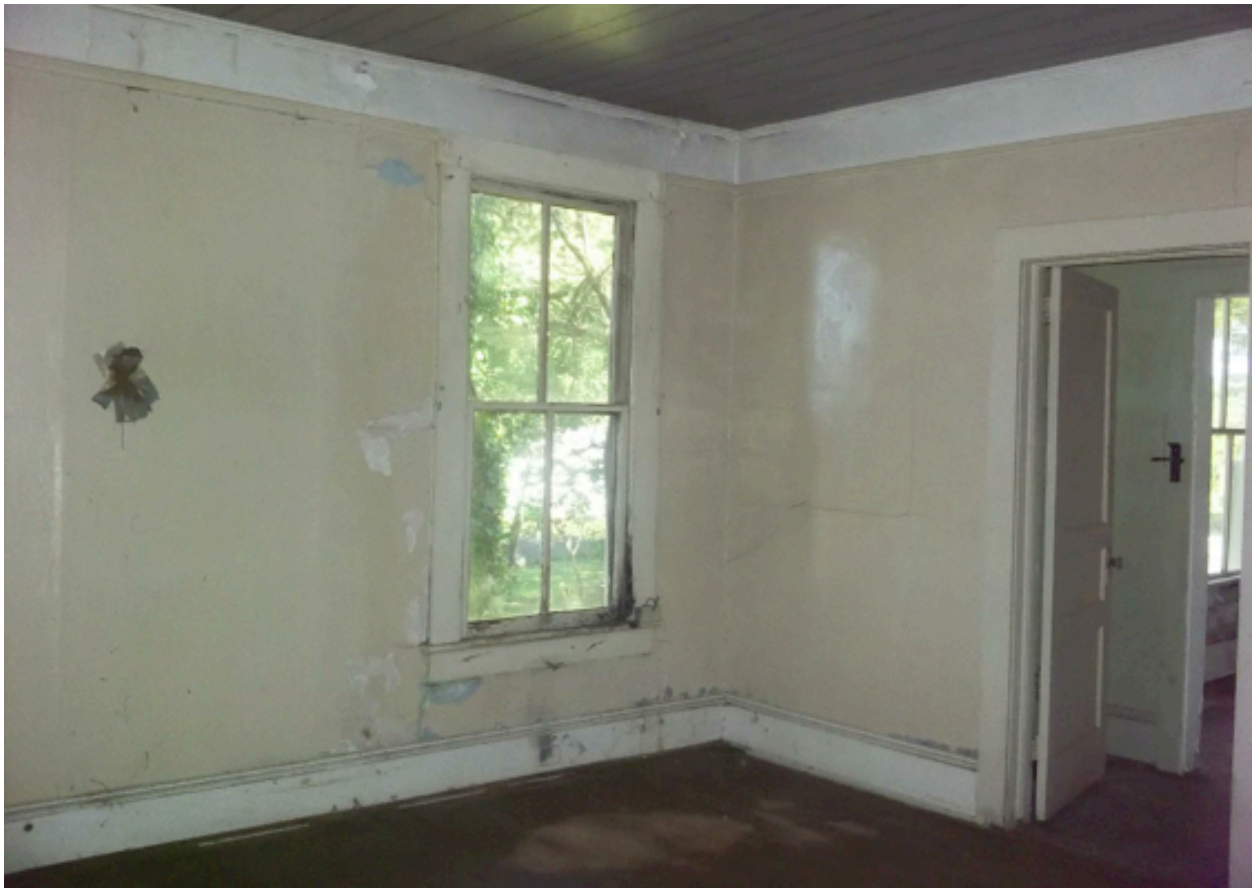
Figure 3.93: Northeast corner of room 101, depicting wall damage. Eastern door to the right leads to room 102.

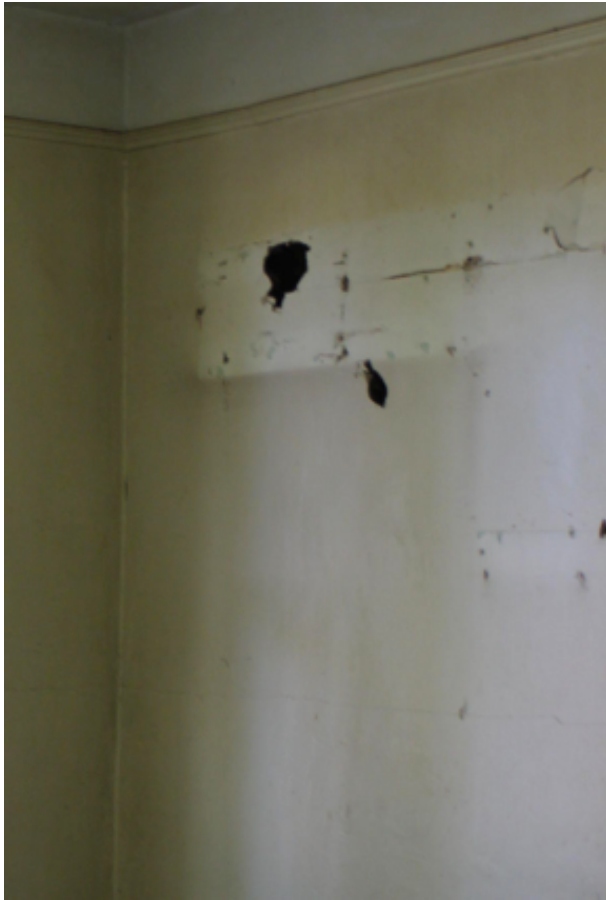
Figure 3.100: Damaged by animal incursion and the removal of fixtures in the east wall of room 202.

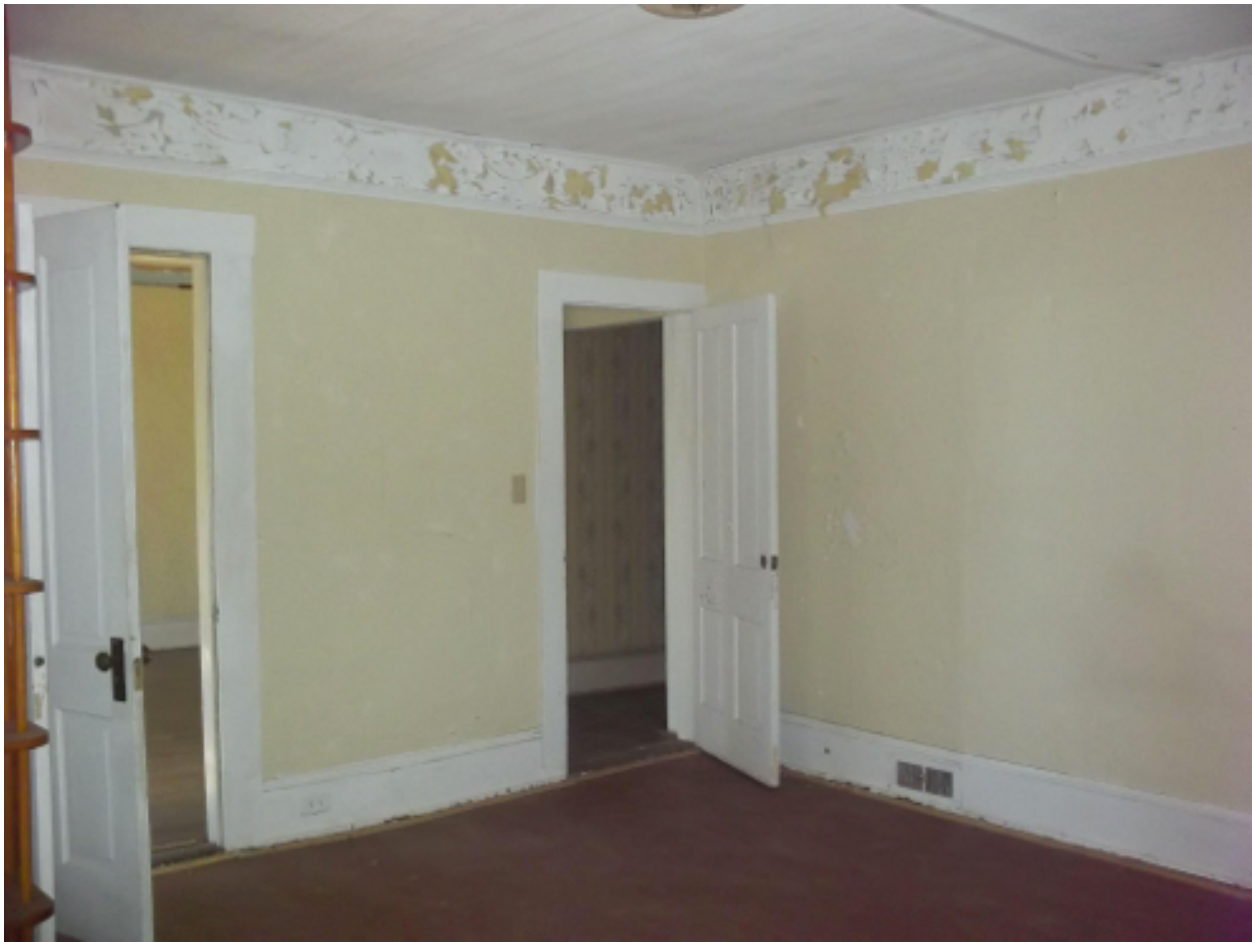
Figure 3.110: Northwest corner of Room 205. The right is the exit into the hall (Room 204), the left leads into Room 206. Note the damage to the area above the picture molding and the ceiling surface material.

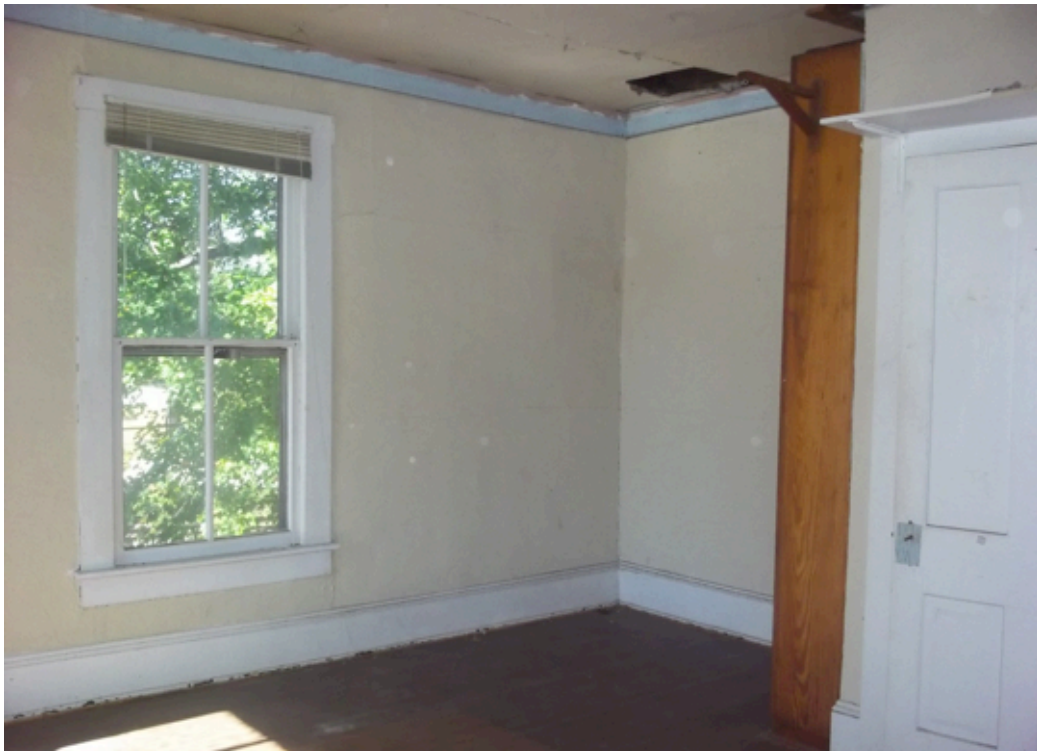
Figure 3.111: Northwest corner of Room 206. The ceiling damage is evident, some portions from being cut, some from having hooks inserted into their surface to secure a drop ceiling. Note painted floor, baseboards, window casement, and missing picture molding. The closet is on the right of the frame.

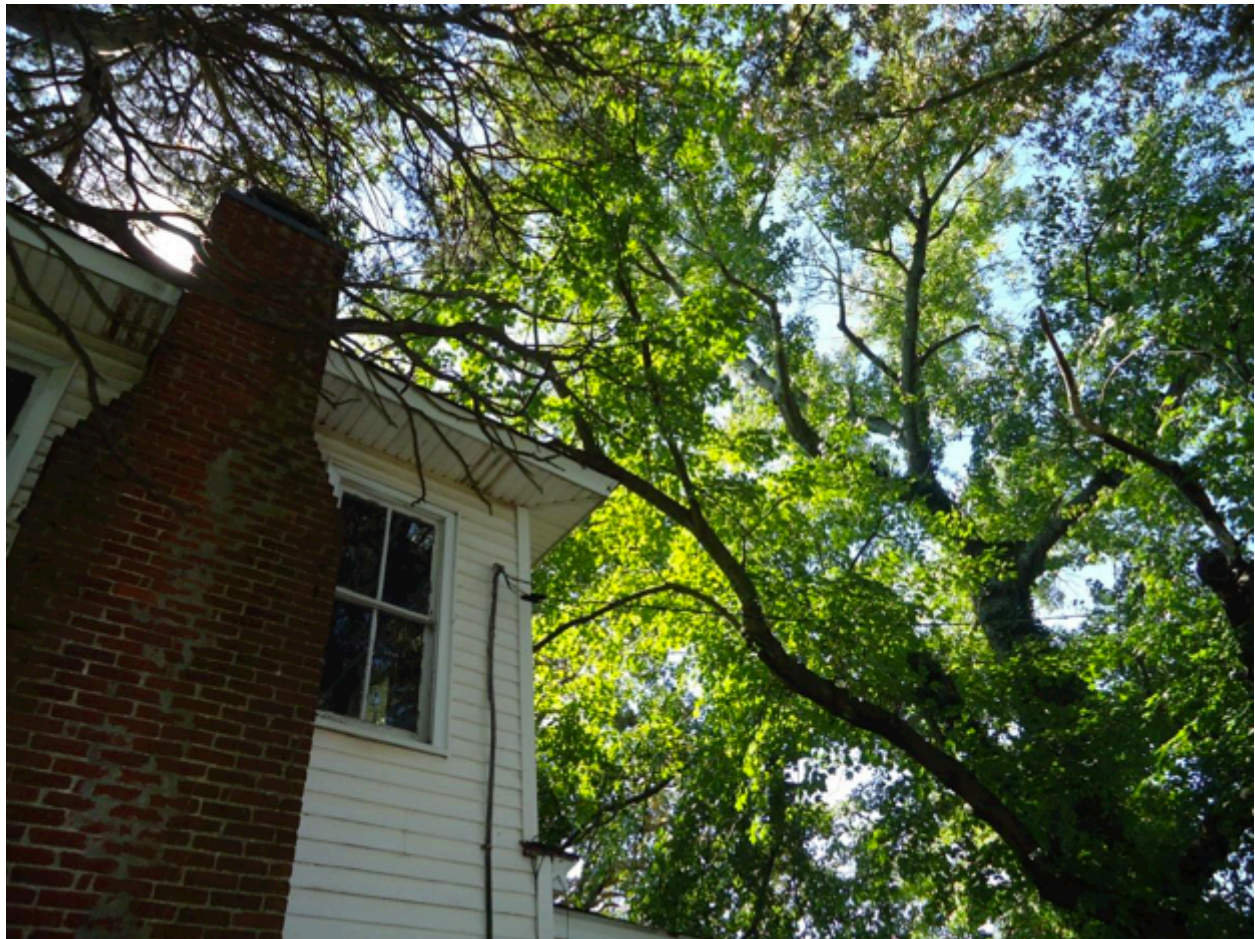
These limbs have the potential to damage the house significantly. Specifically, the maple tree that stands near the northwest corner of the western façade of the Moore House has a substantial number of large limbs that stretch onto the home that have already caused abrasions to the siding and damage to the second-story roof as shown in Figure 4.1. Detail of the large limbs of the maple tree (right) and the cedar tree (upper left) that encroach on the western and northern facades of Moore house structure; moss growth is present on the chimney on the north facade due to microclimate conditions caused by excessive tree coverage.

Figure 4.1: North chimney of the Moore House.

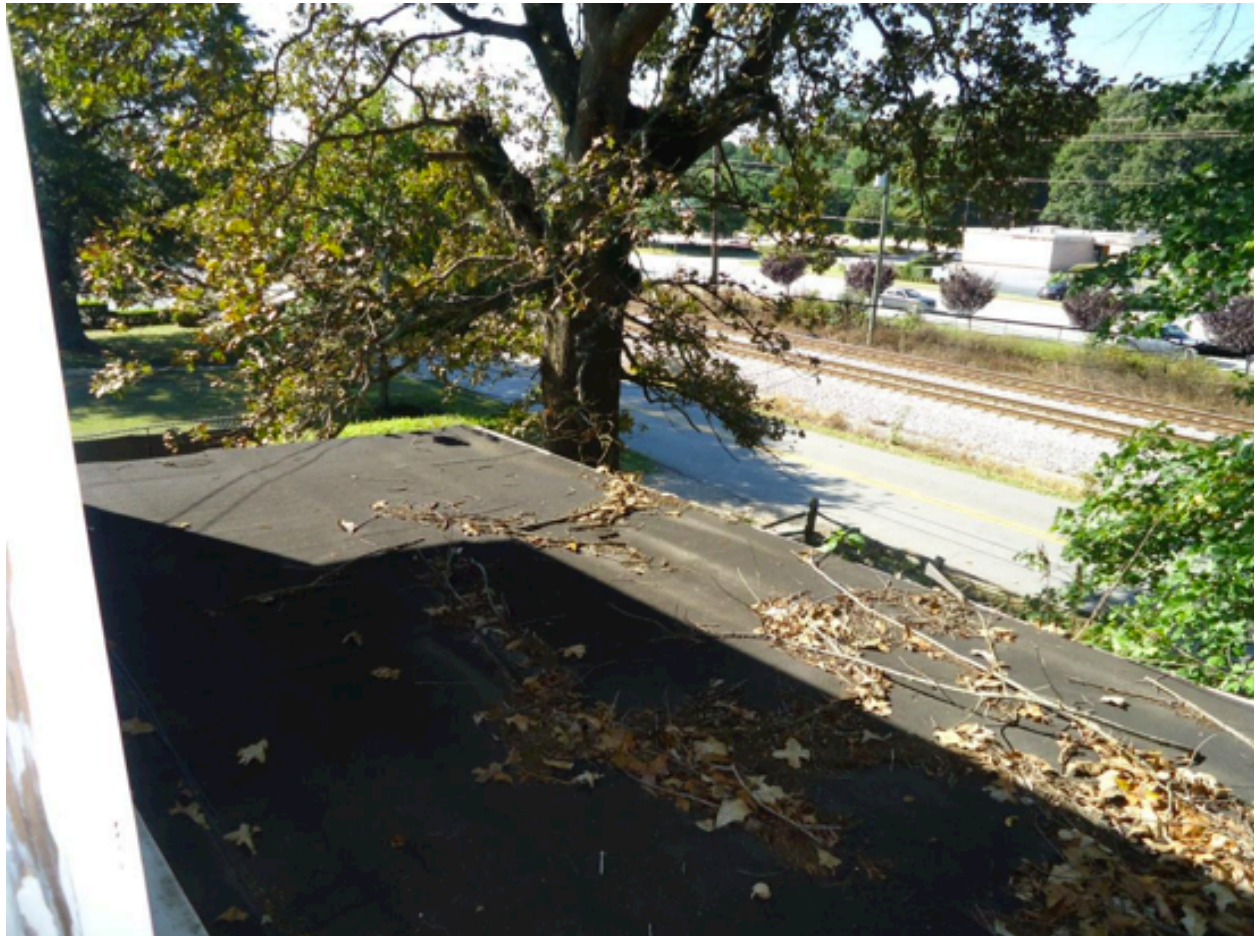
This tree also drops significant amounts of dead limbs and leaves onto the roof of the front porch, putting unnecessary strain on both of these roof sections, while leaf build up facilitates the conditions that lead to trapping moisture and creates rot as shown in Figure 4.2. The cedar tree on the north façade may be dead, and thus presents a high risk of falling onto the house. Currently, some of its limbs are brushing up against the north side of the house as well. Shade coverage on the north façade has prevented sun exposure on and near the chimney, causing moss to form on the historic brick and lime-based mortar. Furthermore, this shady environment has contributed to moisture and rot that has caused a section of the chimney to separate from the second-story of the house as shown in Figure 4.3. If this condition is left unattended, serious deterioration, and ultimately structural failure could result.

Figure 4.2: Roof of porch facing southeast.

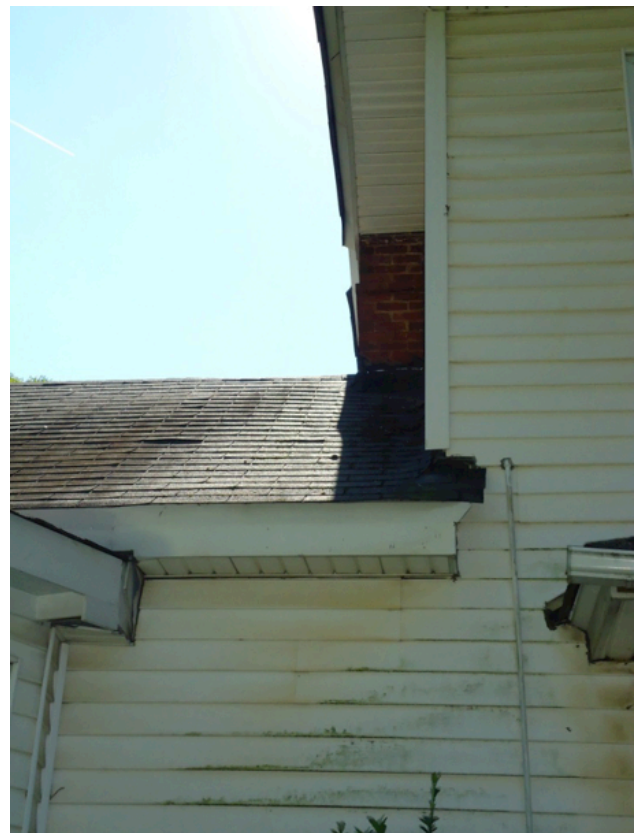
Figure 4.8: Splash molding pattern at corner of pop-out on western side.

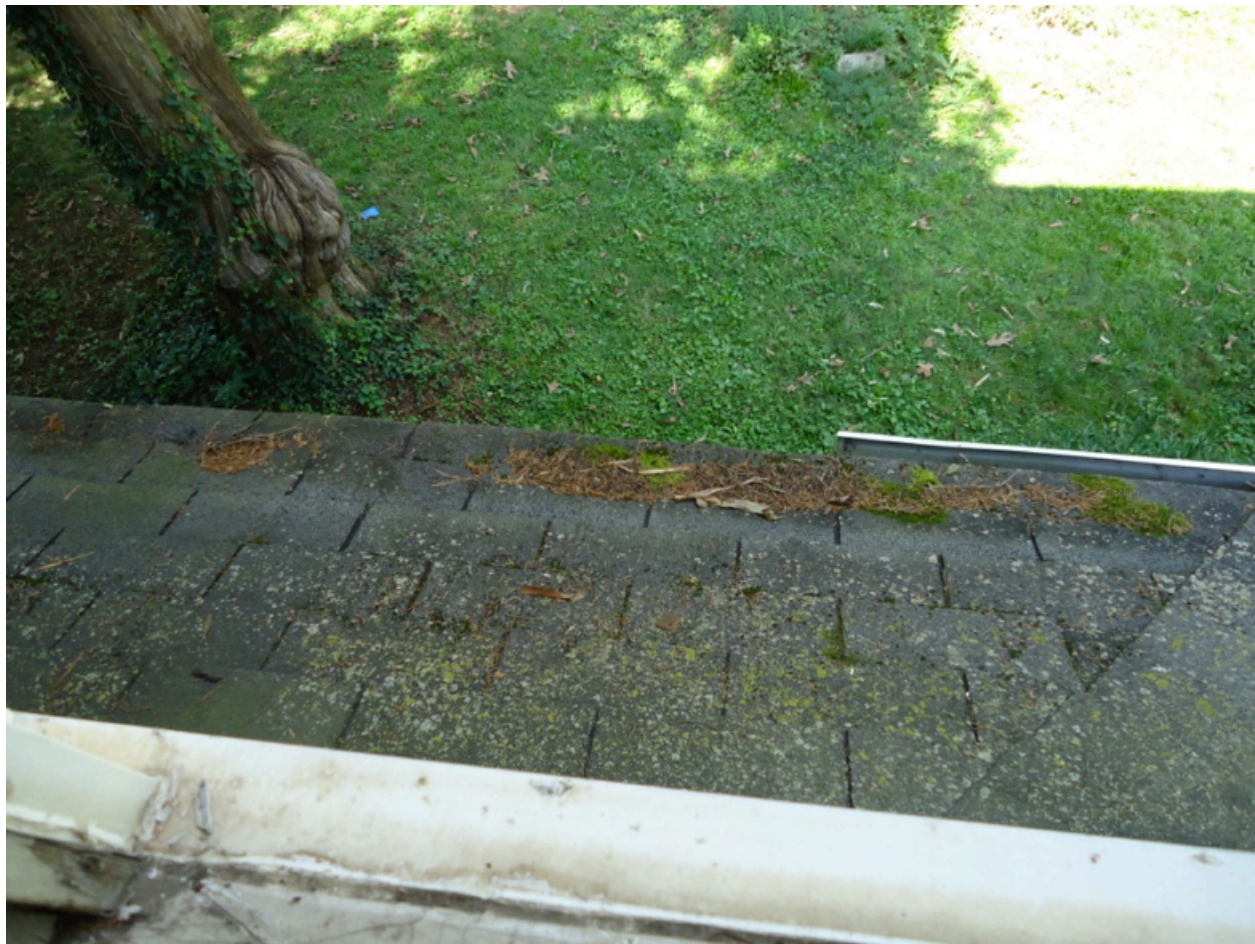
Figure 4.9: Northern pop-out roof molding due to microclimate created by Cedar tree.

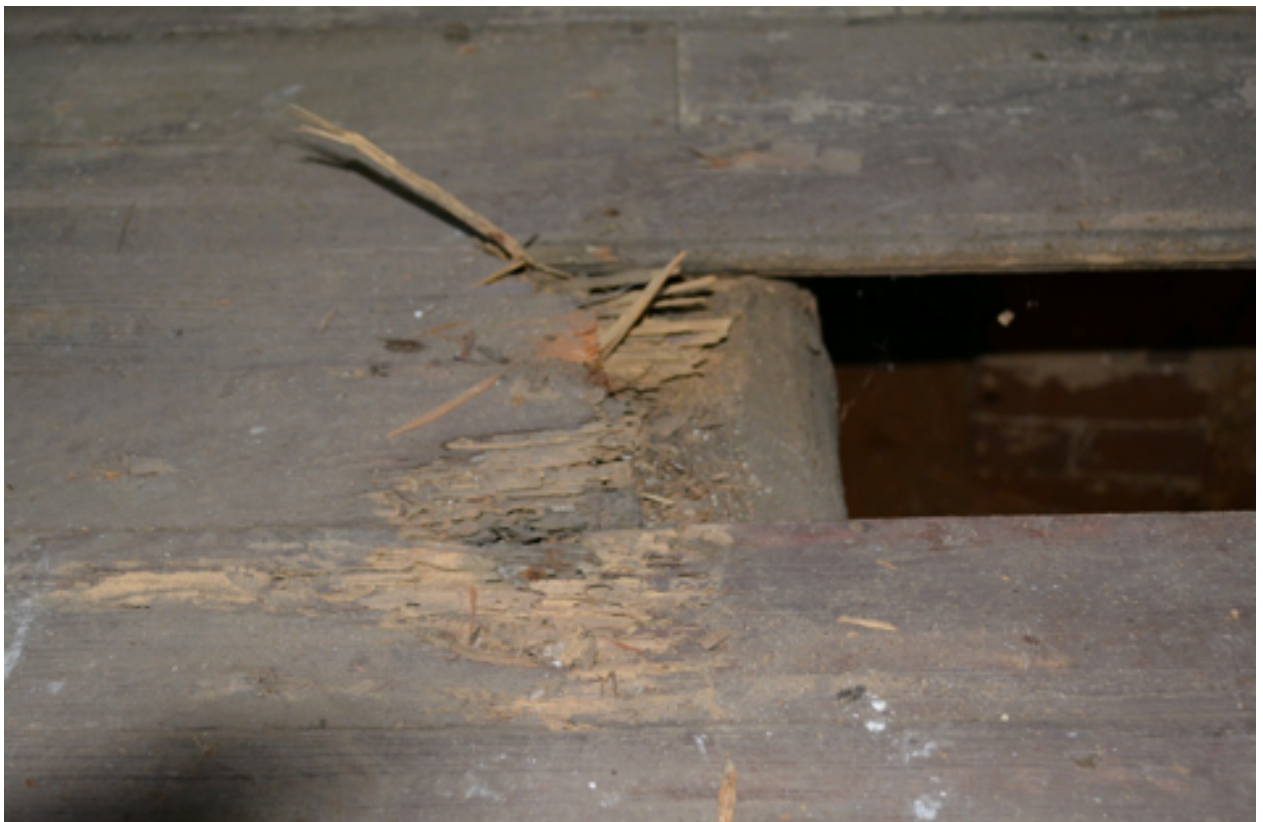
Figure 4.14: Termite damage on original, pine floors.

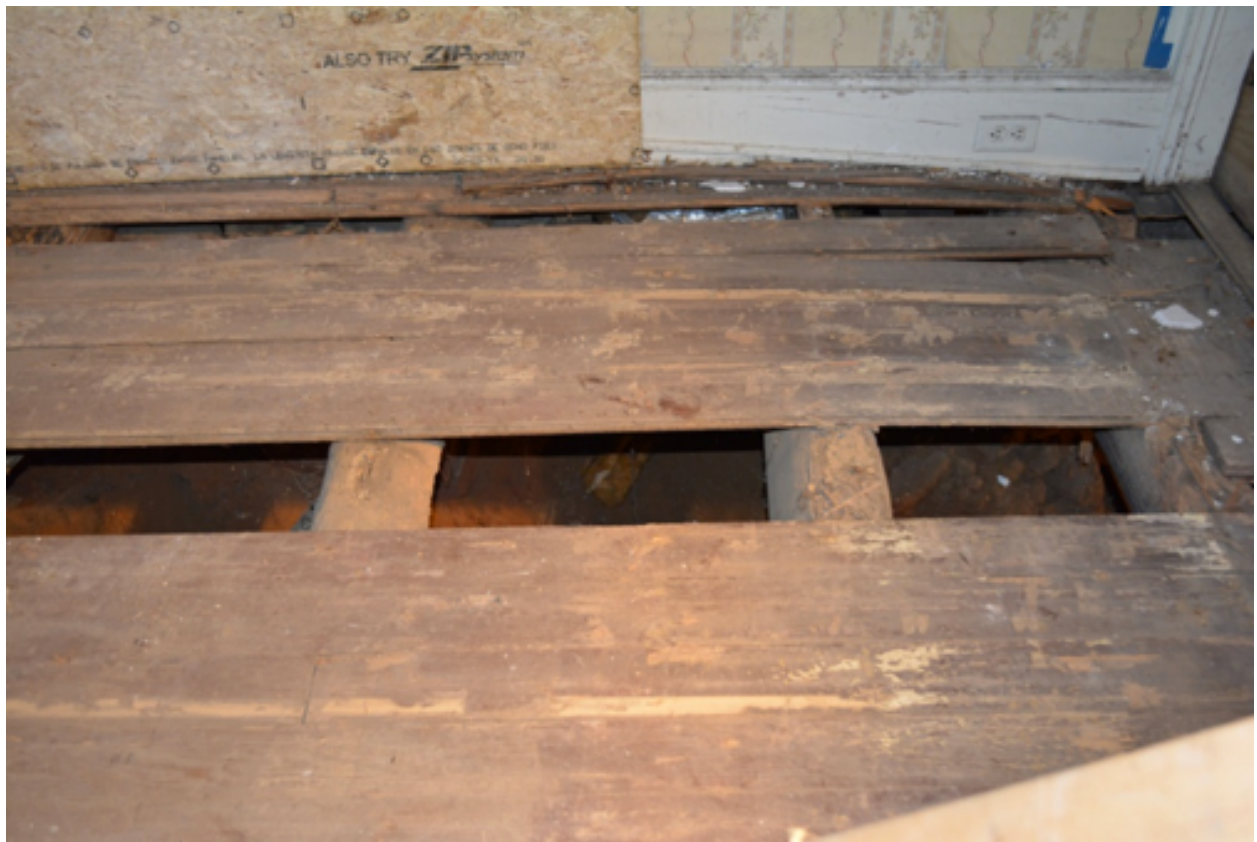
Figure 4.15: Log joists with severe termite damage causing the floor to deteriorate, soften and weaken significantly.

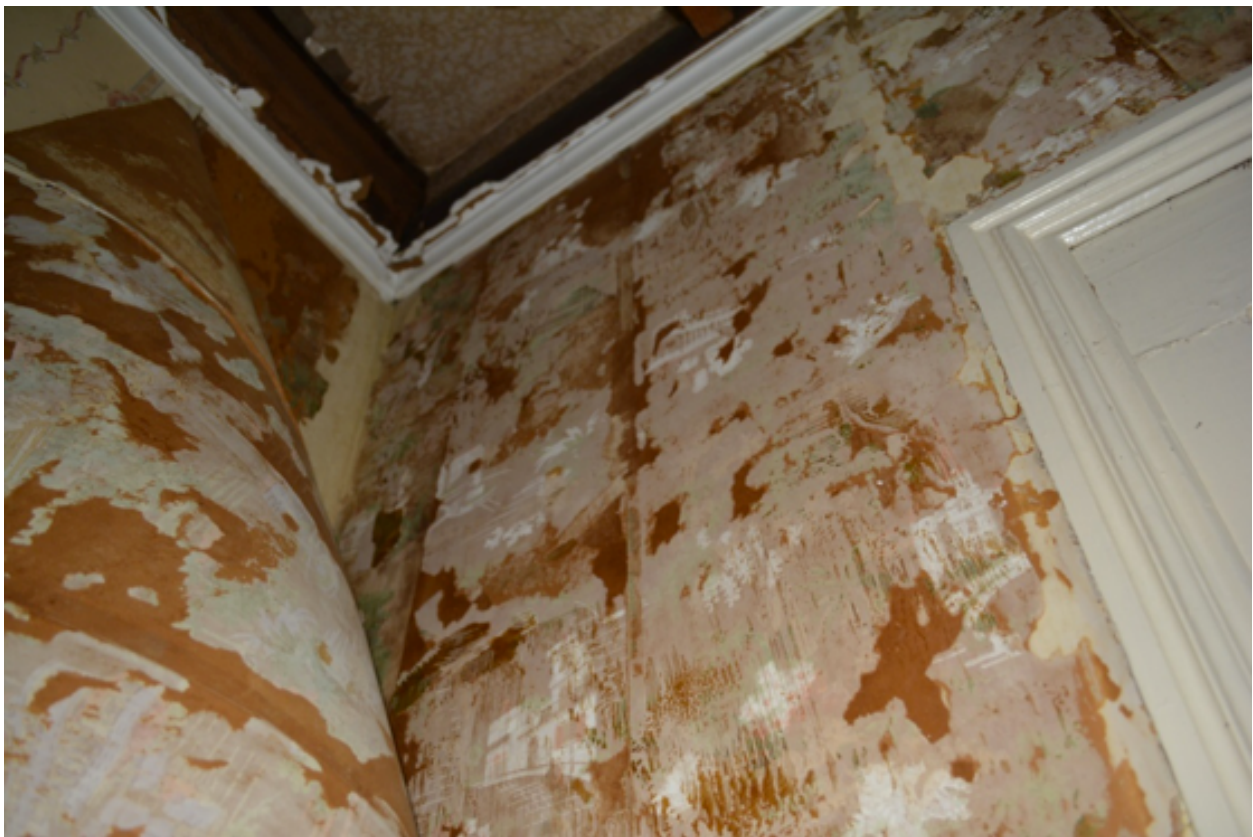
Figure 4.17: Room 101 wallpaper, peeling revealing another layer of wallpaper underneath.

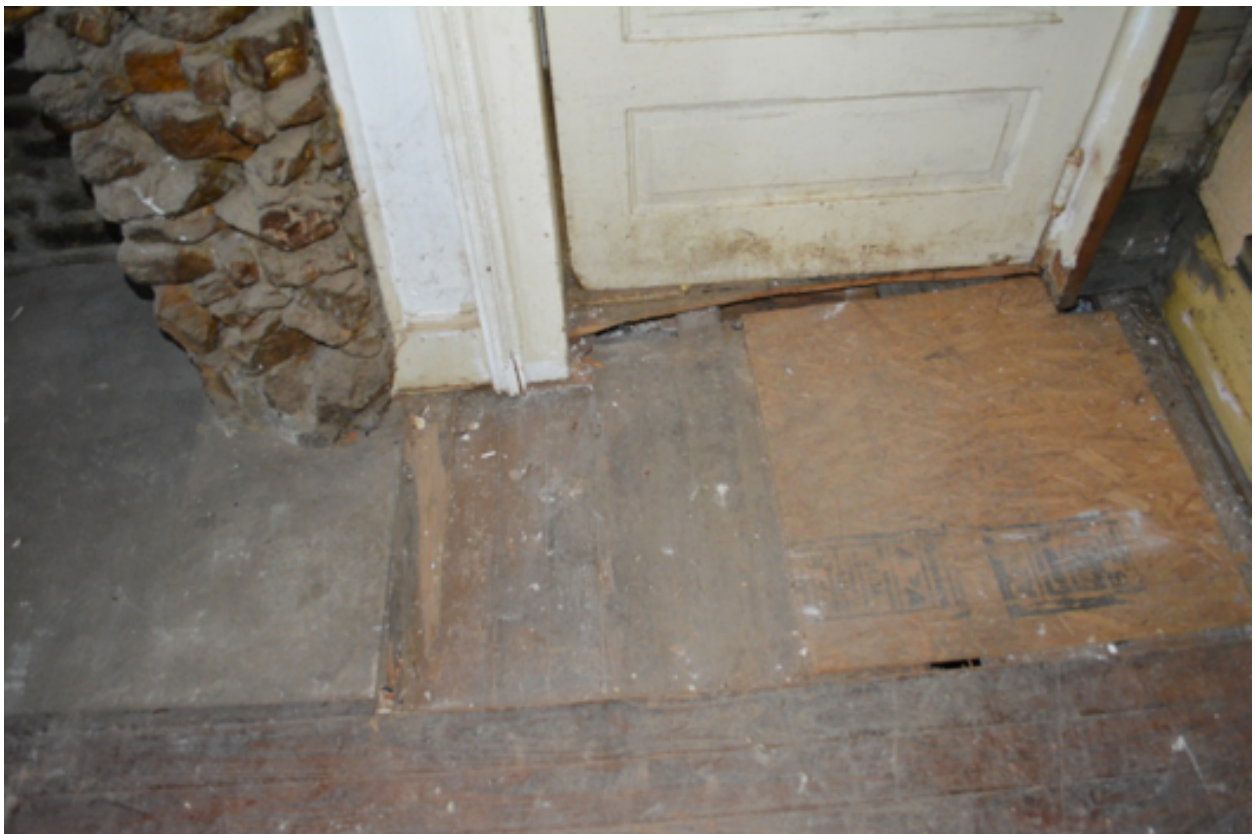
Figure 4.20: Room 102 flooring indication of deteriorating joists and floorboards likely caused by moisture and termite damage.

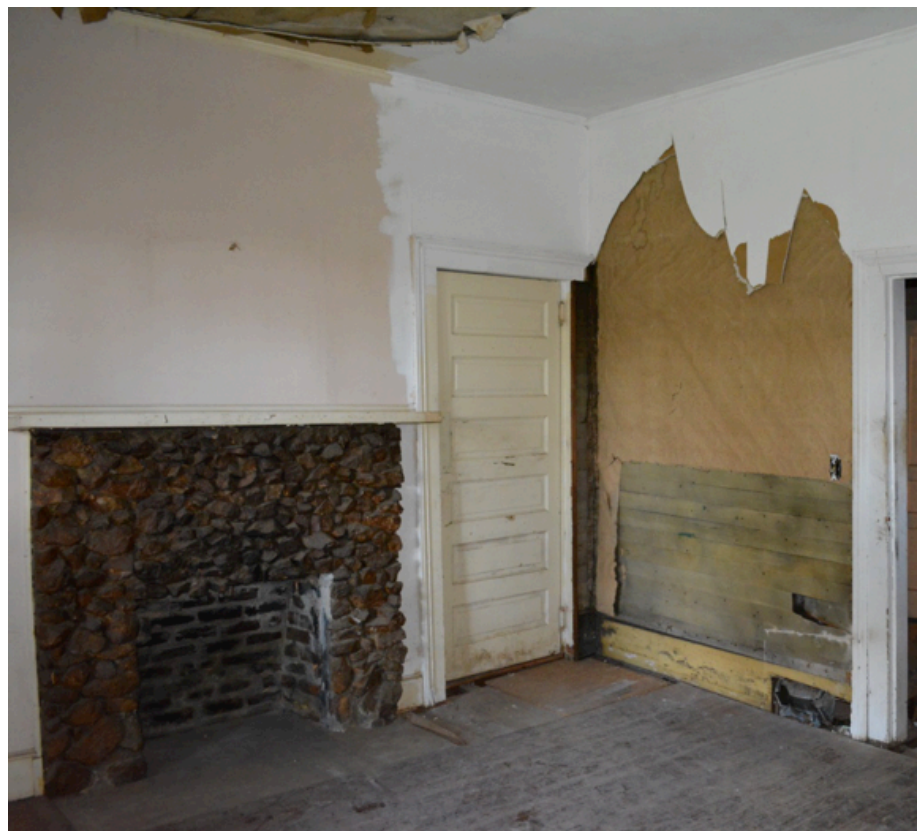
Figure 4.22: Room 102 evidence of water damage behind the drywall.

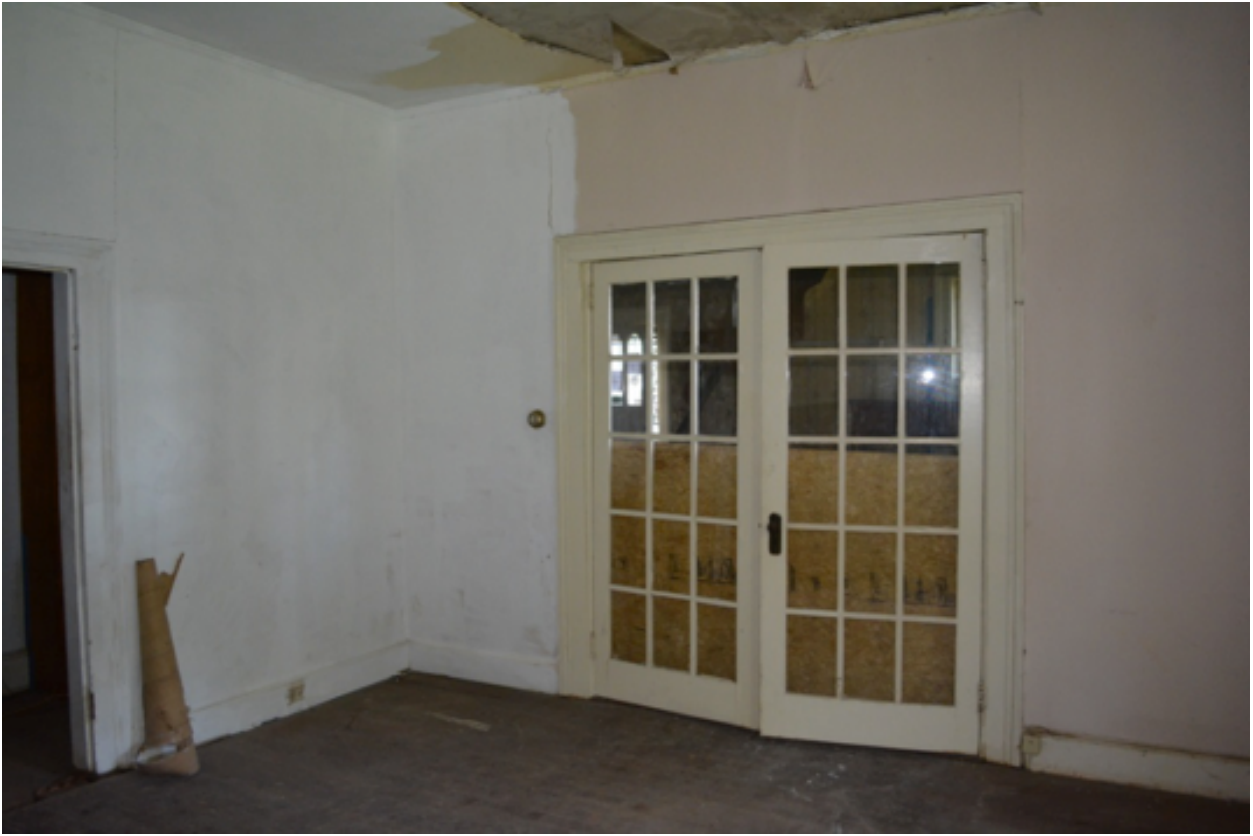
Figure 4.23: Room 102 shows cracks in the drywall intermittently throughout the room.

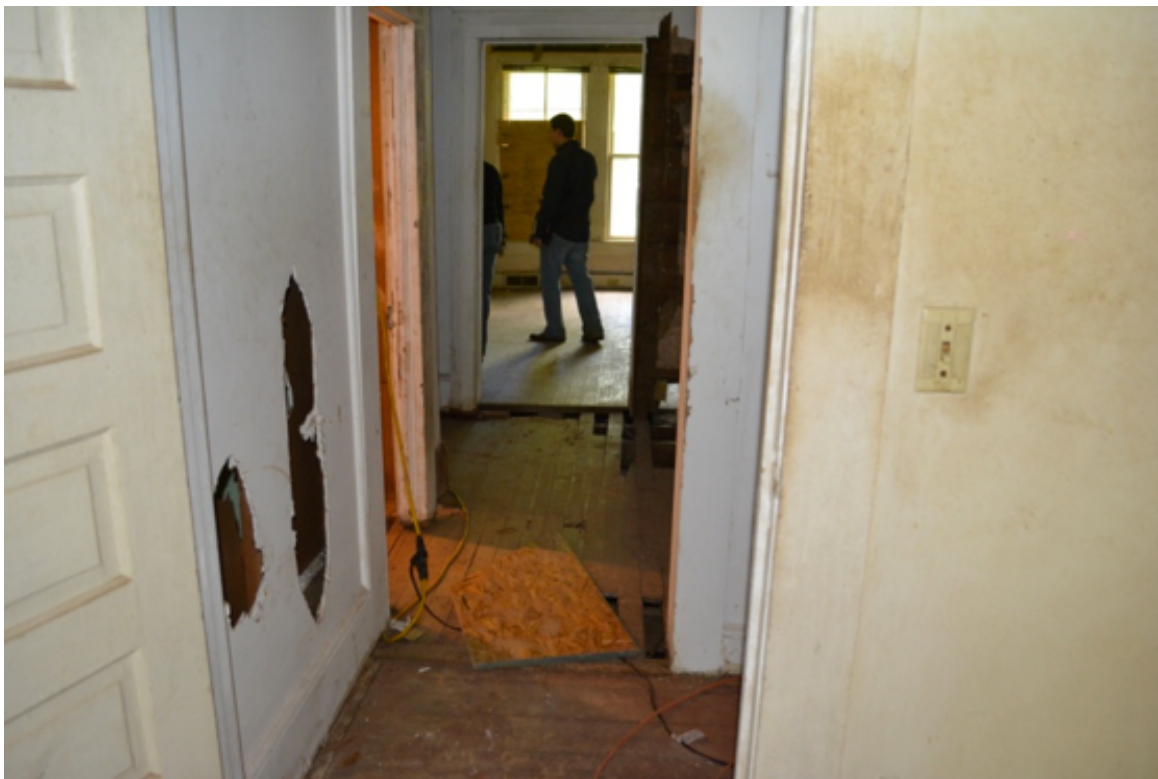
Figure 4.28: Room 104 holes punched through the drywall and plywood covering holes in floor.

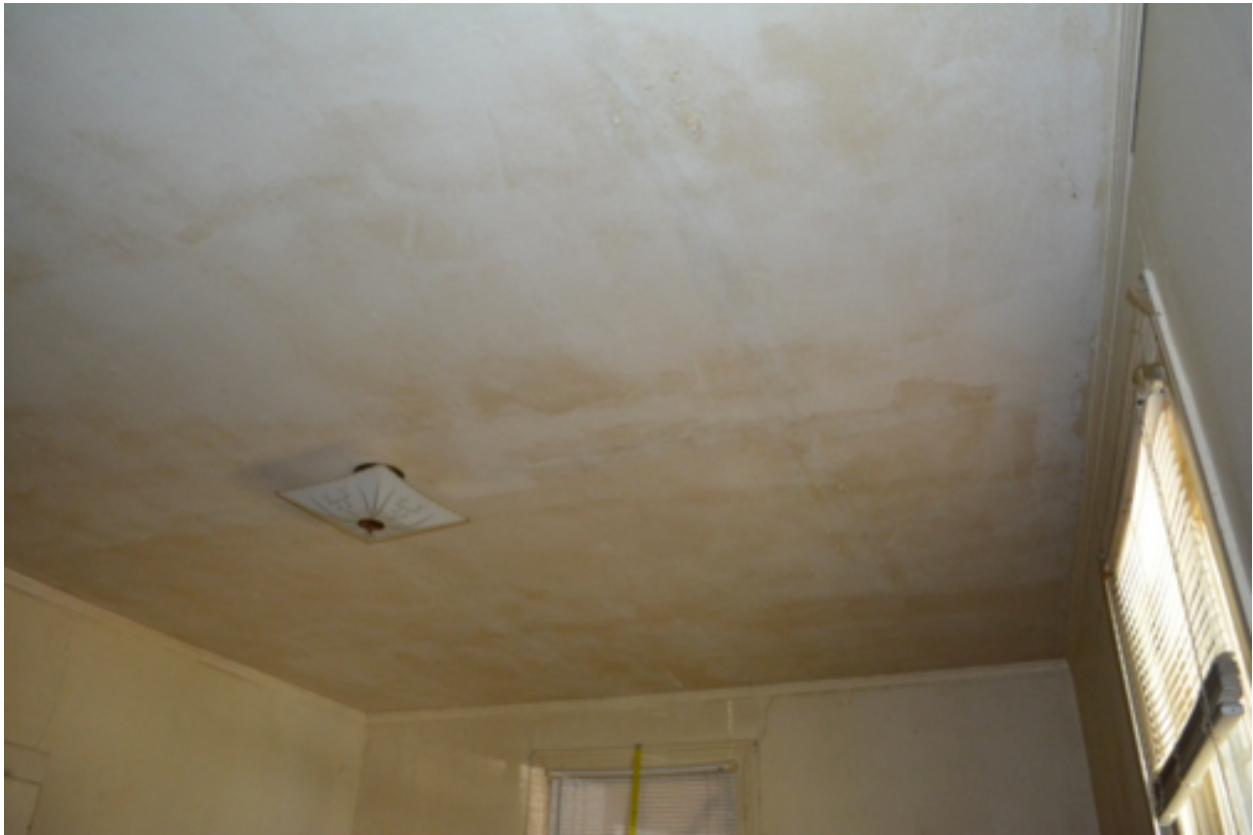
Figure 4.32: Ceiling with water stains and peeling paint in Room 107.

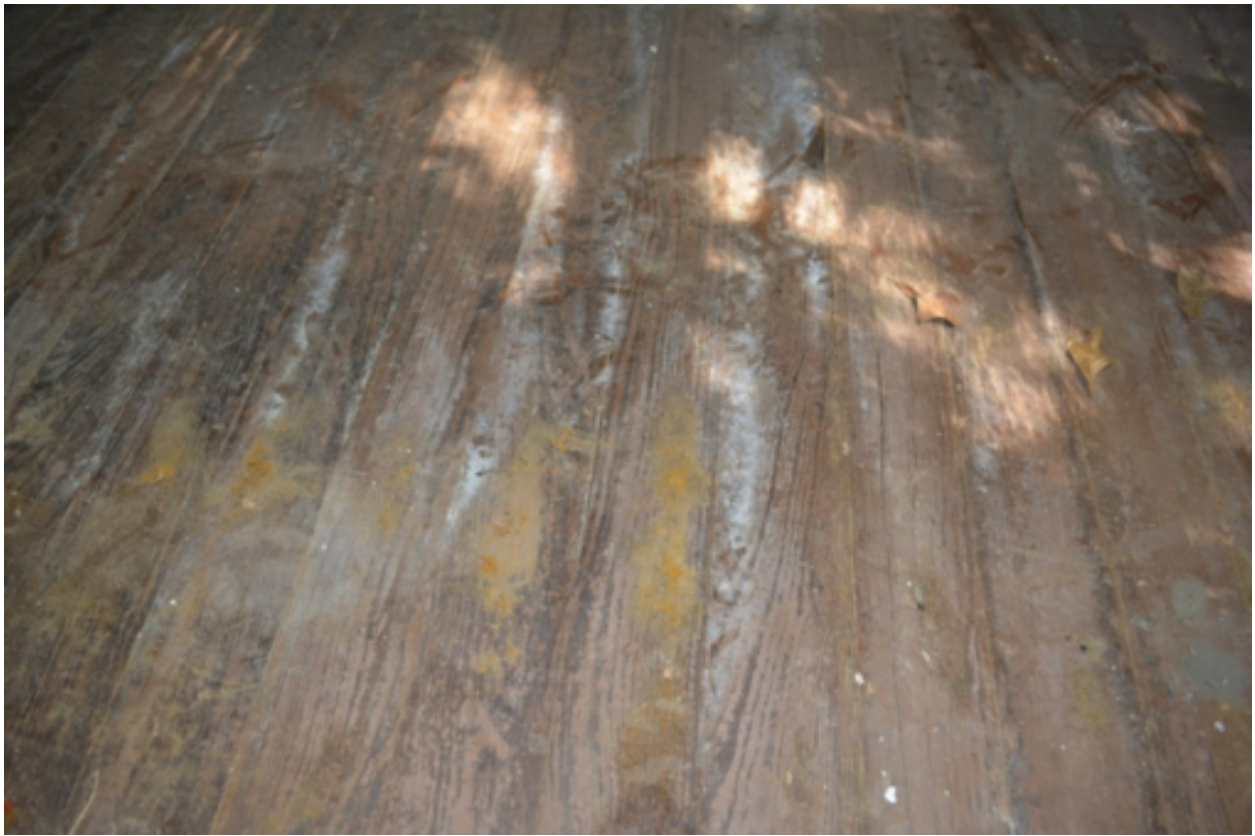
Figure 4.33: White rot on floorboards in Room 107.

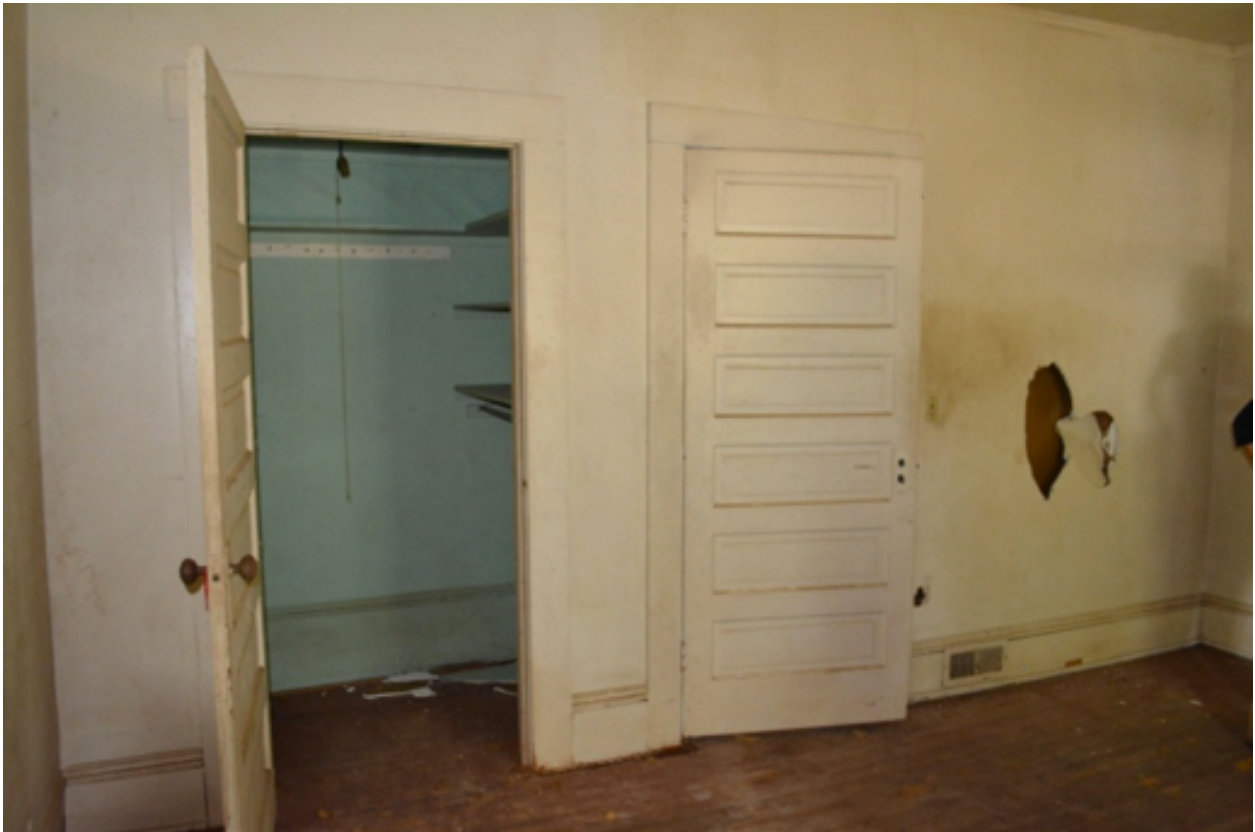
Figure 4.34: Holes in the drywall on north side of room Room 107.

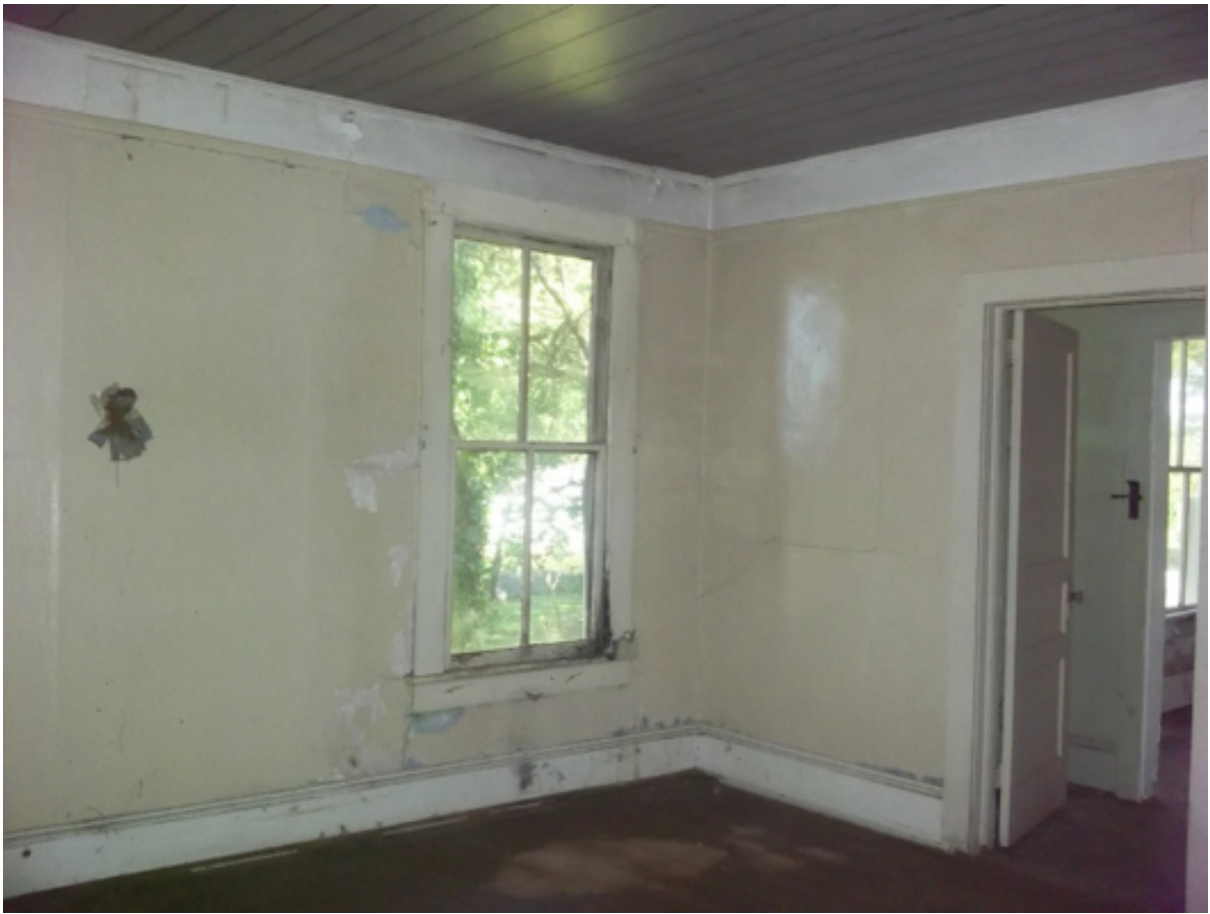
Figure 4.38: Northeast corner of Room 201, showing moisture and animal damage.

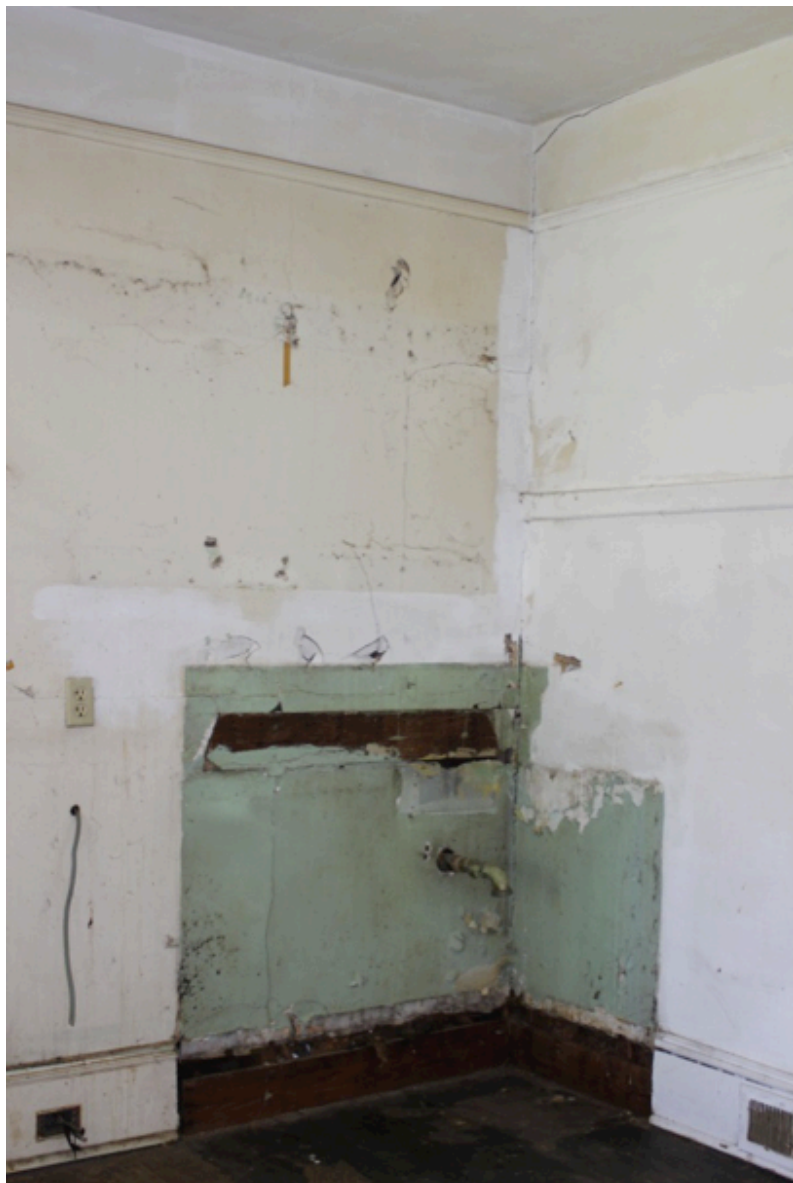
Figure 4.40: Southeast corner of Room 202, depicting wall damage.

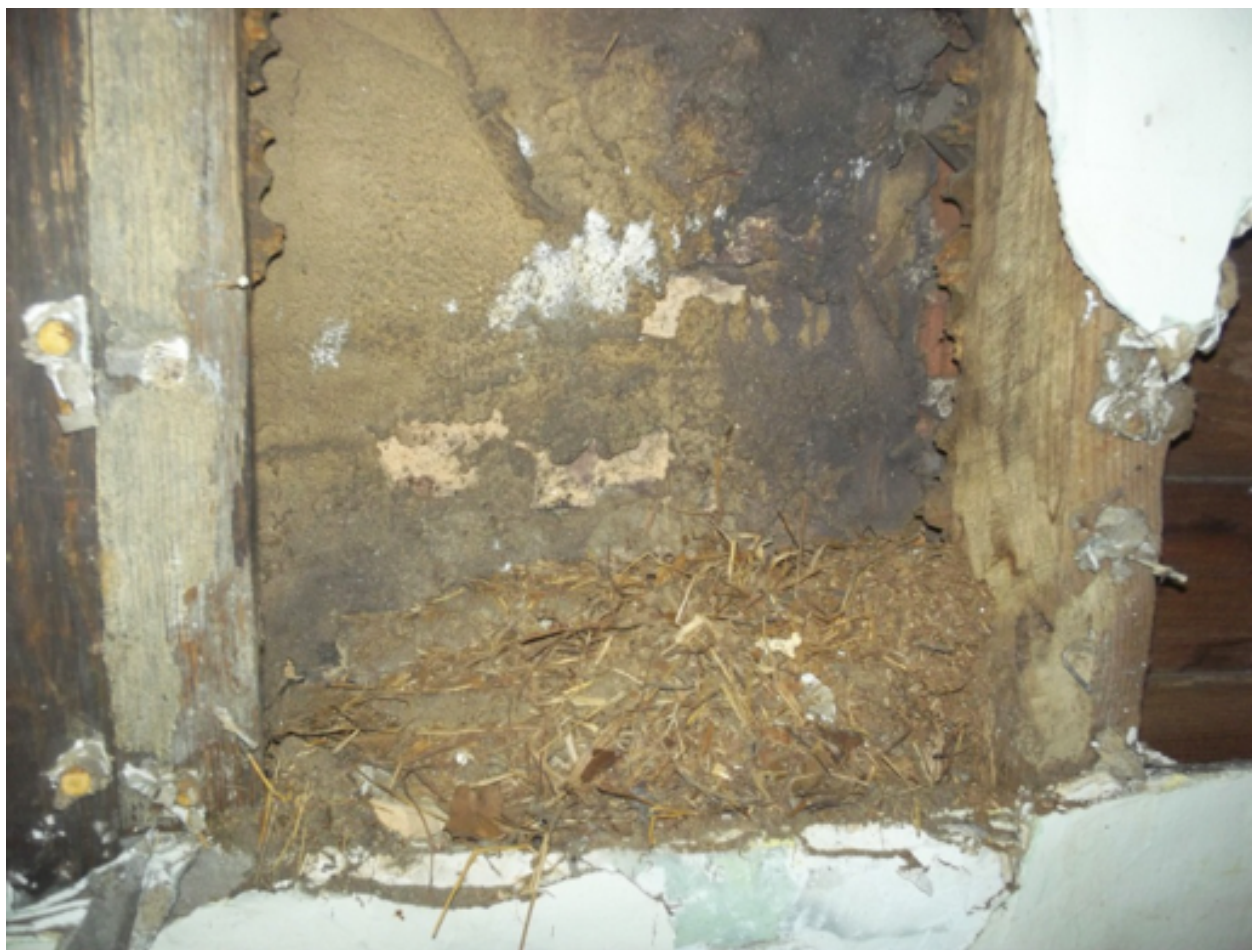
Figure 4.41: Animal Burrow Room 202.
